# PERFORMANCE OF FLOOD-TESTED SOIL-CEMENT PROTECTED LEVEES

**Kenneth D. Hansen, P.E.<sup>1</sup>**  
**Dennis L. Richards, P.E.<sup>2</sup>**  
**Mark E. Krebs, P.E.<sup>3</sup>**

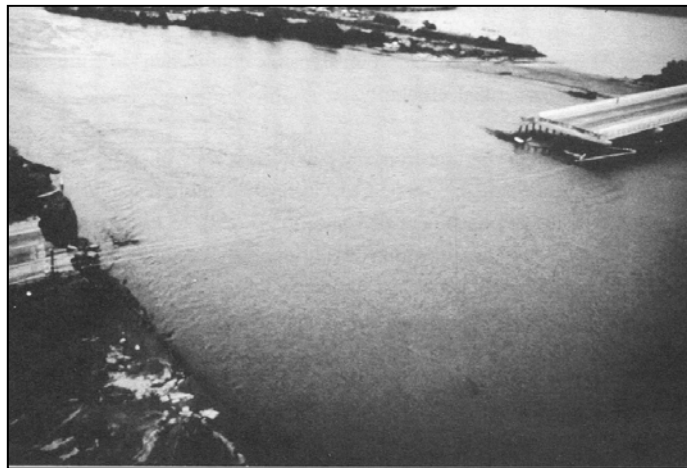
Damage caused by the flood was estimated at \$105.7 million. Four deaths were also attributed to the flood. All but one of the bridges spanning the Santa Cruz River were put out of service due to erosion at the abutments. See Figure 4.

Figure 4. Washed out Bridge Abutment on Santa Cruz River

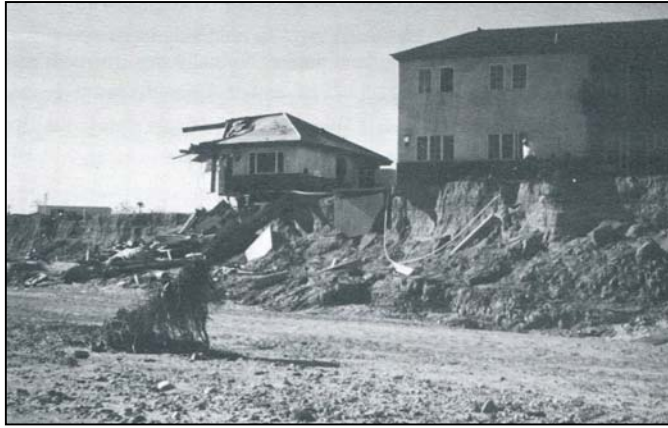
A total of 154 residential units were destroyed and 382 more received either major or minor damage according to FEMA. Most of these residences were located adjacent to the Rillito River (also called Rillito Creek in some later reports). See Figure 5.

Figure 5. Damaged Office Building on the Rillito River

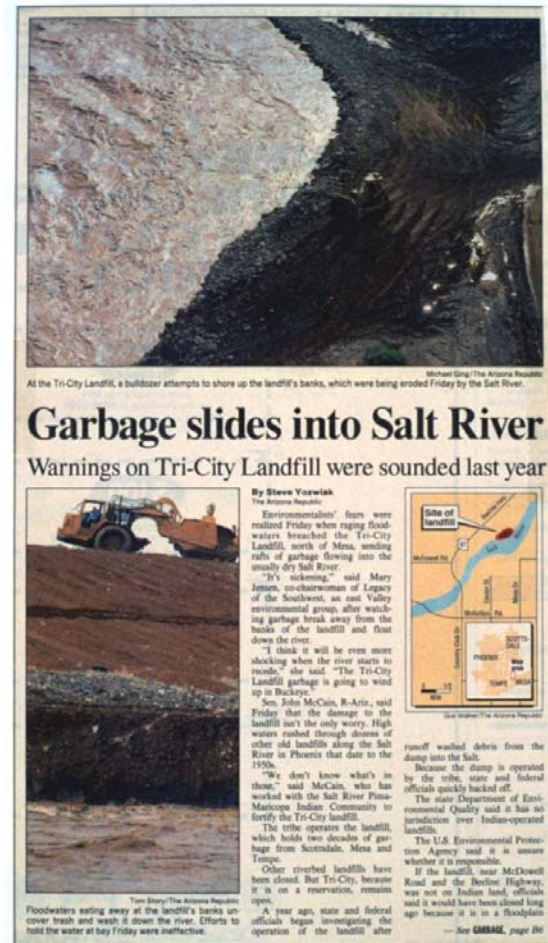
The unprotected banks of the Tri City Landfill north of Mesa was breached during the January 1993 flood. This caused garbage to enter the flood flow. See Figure 8.

Figure 8. Unprotected Tri City Landfill

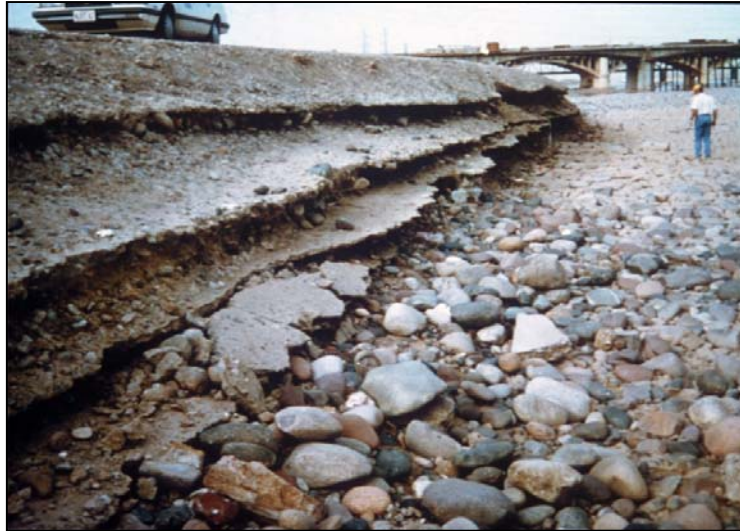
Once again CSA protected banks performed well when subjected to high velocity, turbulent flow containing a significant amount of cobbles, gravel, and sand. Figure 9 shows some scouring of the CSA levee along the Salt River at Tempe. Please note the size of the "boulders" that acted upon the CSA levee protection at a relatively high velocity.

Figure 9. Scour of Cement Stabilized Alluvium along Salt River at Tempe, Arizona

The unusual case of an extreme flow carrying large cobbles and boulders greater than 9-inch size was the 1993 flood on the Salt River through the Phoenix area. The banks were protected with what is called cement-stabilized alluvium (CSA) using the same material, but with the rocks greater than 3-inch size scalped off. CSA is a term only applied to protection of the Salt River in Maricopa County, Arizona. It is probably closer to roller-compacted concrete (RCC) than soil-cement due to the large maximum size aggregate used. Figure 9 shows some scouring of soil-cement levee along the Salt River through Tempe, Arizona, east of Phoenix. The scouring is likely due to a combination of (1) the inability to provide adequate compaction at the outer edge of the soil-cement lifts and (2) the large material transported by the river system during large volume flow events tending to abrade the cement stabilized alluvium.

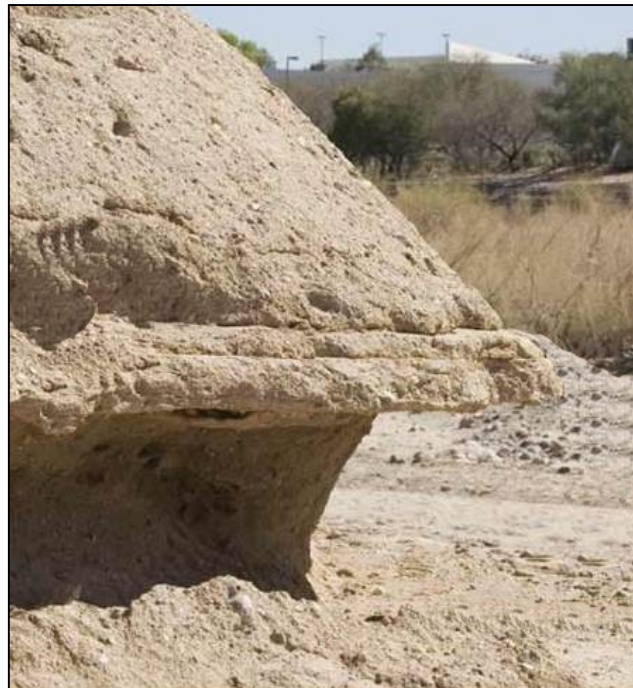
Approximately 225 feet out of a total 10.8 miles (less than 0.7 percent) of the Corps designed soil-cement levee protection was undercut due to inadequate toe-down depths. Repair of this stretch was estimated to cost \$310,000. See Figure 11.

Figure 11. Under cutting of Soil-Cement along Rillito River (2006)

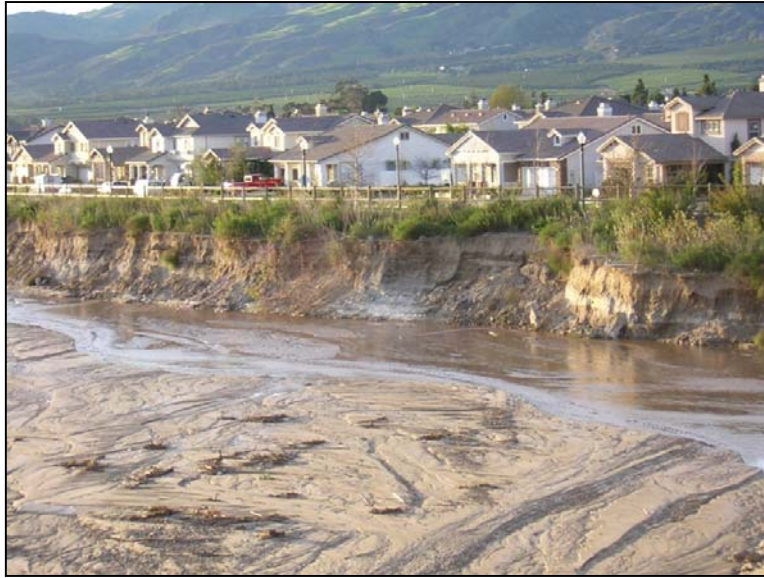
Downstream from Santa Clarita, buried soil-cement was used to protect a housing development at Fillmore, California. Flow in the Santa Clara River caused by January 2005 storms eroded the sand banks and exposed some buried soil-cement, as intended by design. There was no damage to the nearby houses. See Figure 14.

Figure 14. Erosion of bank at Fillmore, CA exposed some buried soil-cement

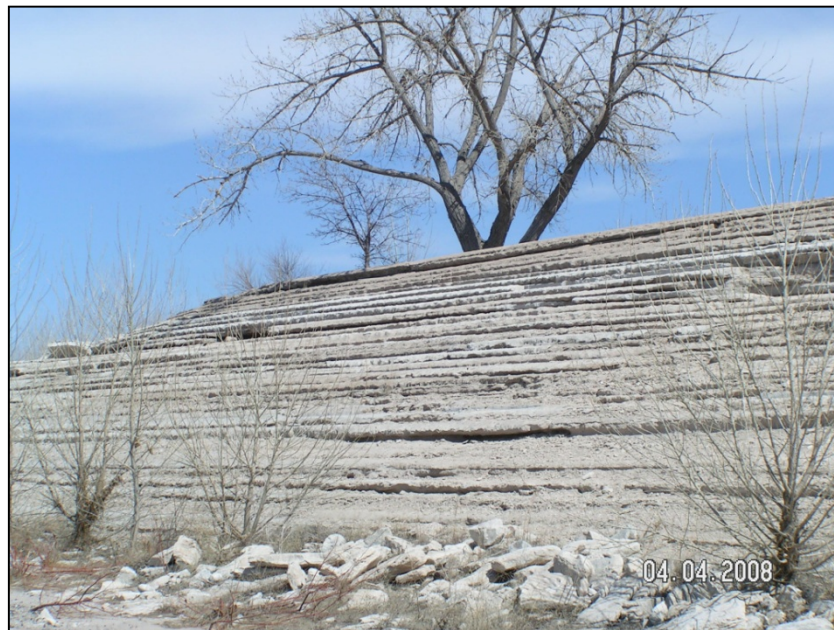
As shown in Figure 15, taken in 2008, there has been some breakage of soil-cement layers due to poor bond between the individual 6-inch thick soil-cement layers. The lower portion of the lifts were thus subject to wave erosion due to lower cement content at the bottom of the layers that is typical of the in-place mixing method together with lower density in this area due to the compaction method.

Figure 15. Bonny Reservoir Test Section after 57 years of exposure

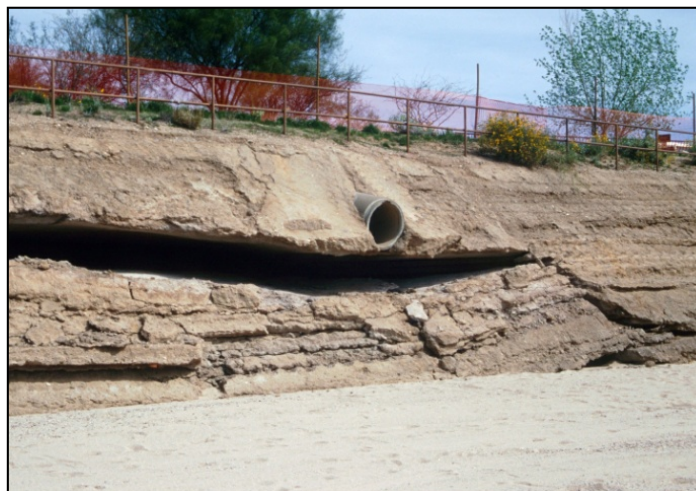
As shown in Fig. 16, the soil-cement has apparently lost support of its foundation. This has caused the soil-cement to separate at a weak lift line, break up somewhat and settle. This occurred on the Rillito River west of Oracle Road at Tucson, Arizona following the 1993 flood.

Figure 16. Soil-Cement Bank Protection on Rillito River, Tucson, Arizona

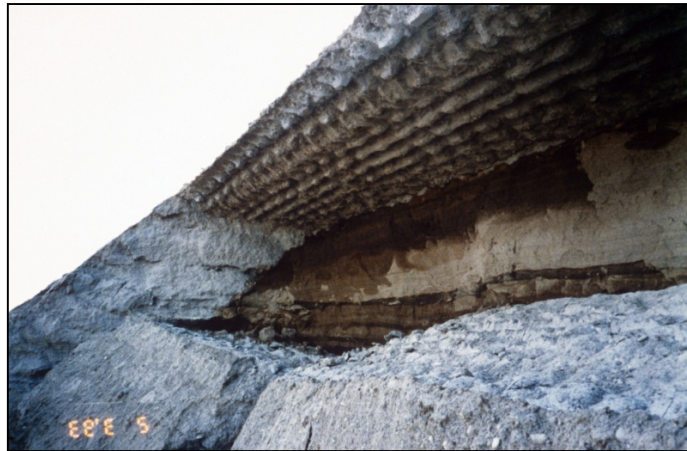
An even more dramatic result of scour below soil-cement bank protection is shown in Fig. 17. On the Santa Cruz River downstream from the Cortaro Road north of Tucson, a loss of support has caused the soil-cement to drop into what is assumed to be a scour hole. This caused the 24 inch soil-cement section above the gap to span 107 ft. at the time of this photo. Note the imprints from what appears to be a pad foot roller on the underside of the soil-cement “bridge”.

Figure 17. Settlement of Soil-Cement Bank Protection on Santa Cruz River, north of Tucson, Arizona

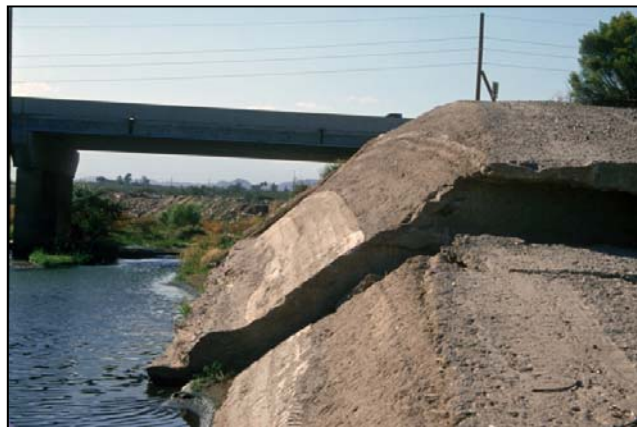
The second condition concerns a vertical displacement of soil-cement bank protection on the Santa Cruz River downstream of the Ina Road Bridge, north of Tucson. It is unclear as to the cause of this occurrence, except one section of soil-cement separated and moved downward and slightly back from the adjacent soil-cement. See Figure 18.

Figure 18. Displacement of Soil-Cement Bank Protection, north of Tucson, Arizona

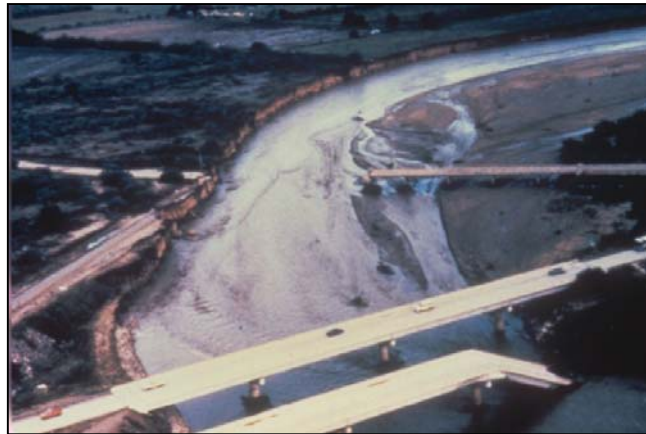
Figure 19 shows a span of the I-19 Bridge across the Santa Cruz River south of Tucson collapsing due to lack of support from an eroded abutment. It also shows the river eroded away the left bank and abutment for the local bridge in the background.

Figure 19. Collapse of I-19 Bridge south of Tucson, Arizona

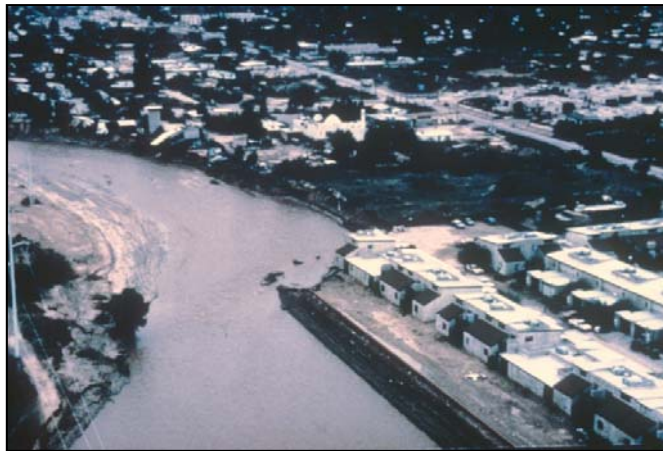
In Figure 20, on the Rillito River in Tucson near Country Club Road a comparison of soil-cement protected bank in the foreground with an unprotected bank is graphically shown.

Figure 20. Comparison Soil-Cement and Unprotected Banks on Rillito River, Tucson, Arizona

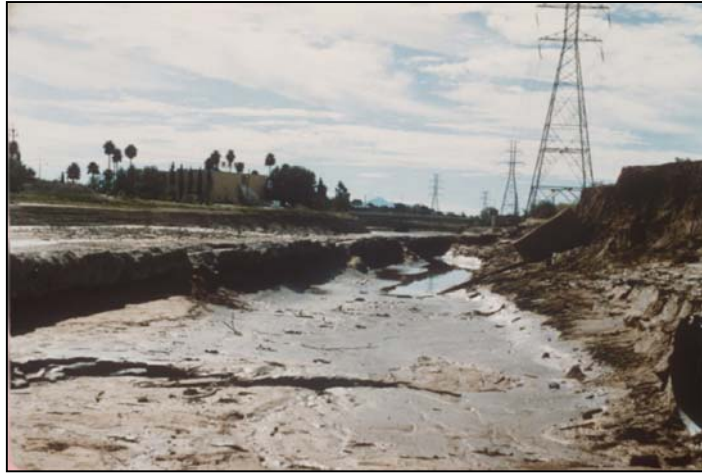
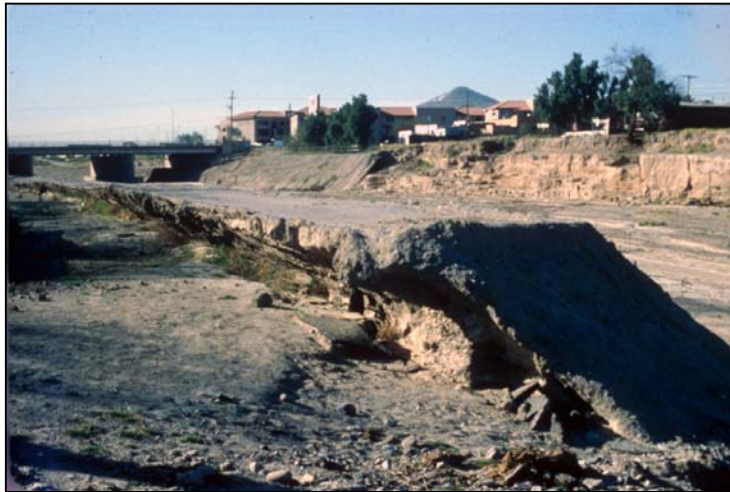
The protection of the Rio Nuevo development adjacent to Santa Cruz near downtown Tucson was only built to the 25-year flood level prior to the 1983 flood which exceeded the 100-year event. Obviously, under these conditions, the soil-cement was overtopped. Some of the embankment behind the soil-cement line washed out. However, the soil-cement was undamaged and was not displaced as shown in Figure 21 and 22.

Figure 21. Overtopping of the Santa Cruz River Levee at Tucson

Figure 22. Downstream end of overtopped soil-cement along the Santa Cruz River

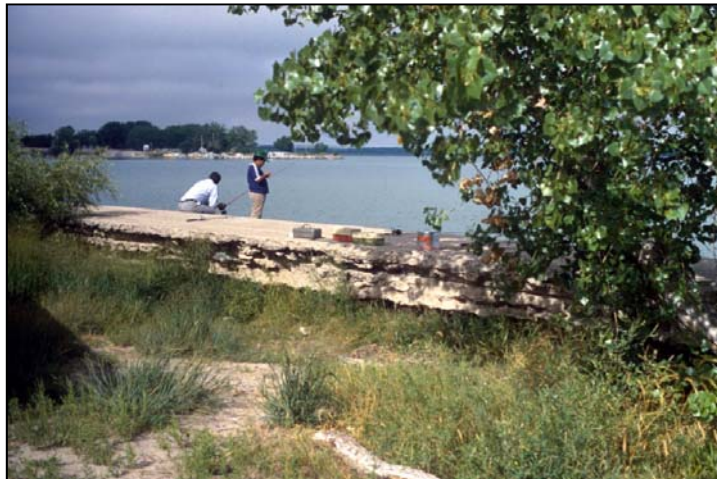
Similarly, the Rillito overtopped its 100-year flood protected banks in 2006 near Dodge Blvd. with no damage. Figure 23 shows the Bonny Reservoir test section after being overtopped on a number of occasions.

Figure 23. Bonny Reservoir Test Section
