# PERFORMANCE OF FLOOD-TESTED SOIL-CEMENT PROTECTED LEVEES

**Kenneth D. Hansen, P.E.<sup>1</sup>**  
**Dennis L. Richards, P.E.<sup>2</sup>**  
**Mark E. Krebs, P.E.<sup>3</sup>**

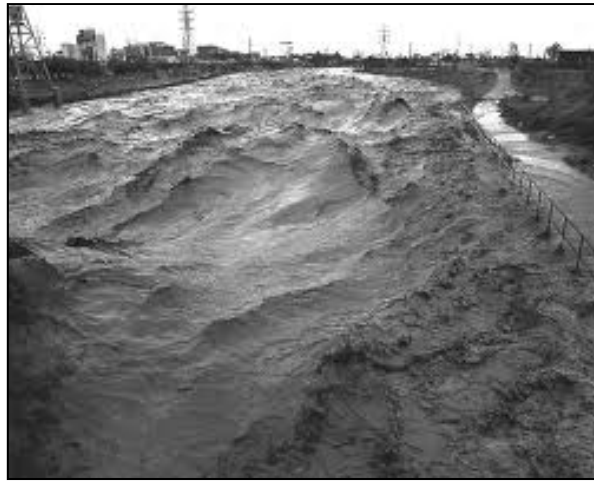
Most of the Tucson, Arizona area received between 6.5 to 7.7 inches of rain over a six day period in October 1983. The heavy rains caused a measured flow record of up to 52,700 cfs on the Santa Cruz River through downtown Tucson. See Figure 3.

Figure 3. Flow in Santa Cruz River on October 2, 1983 looking south from St. Mary's Bridge, near downtown Tucson

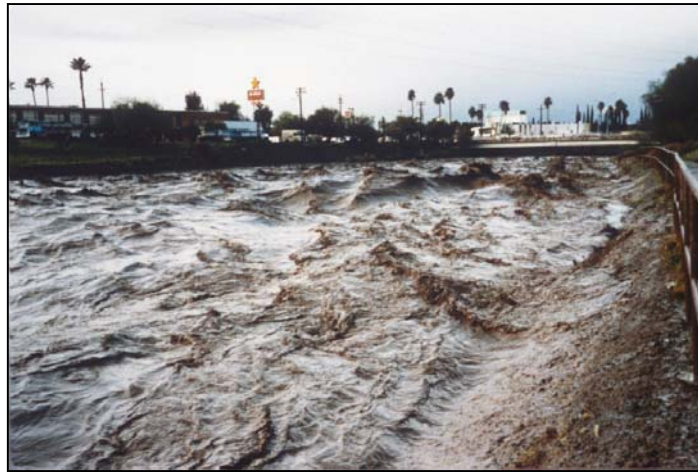
The rainfall produced two distinct flood flows. On January 8, flow in the normally dry Rillito River reached 28,000 cfs. Then, on January 18, the flow in the Santa Cruz River upstream of its confluence with the Rillito reached 35,800 cfs. Even though the peak discharges for the 1993 flood were generally less than the 1983 flood, the soil-cement banks were subjected to flowing water for a longer period of time. Figure 6 shows flow in the Santa Cruz River near downtown Tucson on January 19, 1993.

Figure 6. Flow in Santa Cruz River north of Congress St. Bridge, in 1993

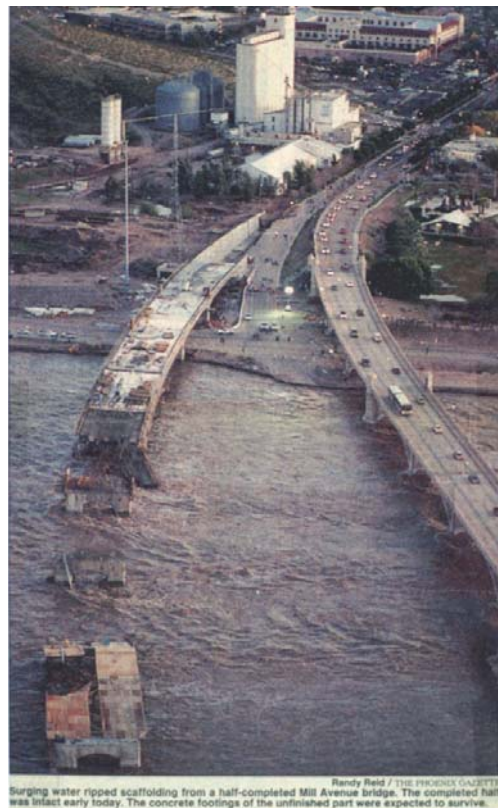
Figure 7. Salt River at Mill Road Bridge

During this flood, portions of the construction formwork for the new Mill Road Bridge under construction across the Salt River located upstream of Phoenix was washed away. See Figure 7.

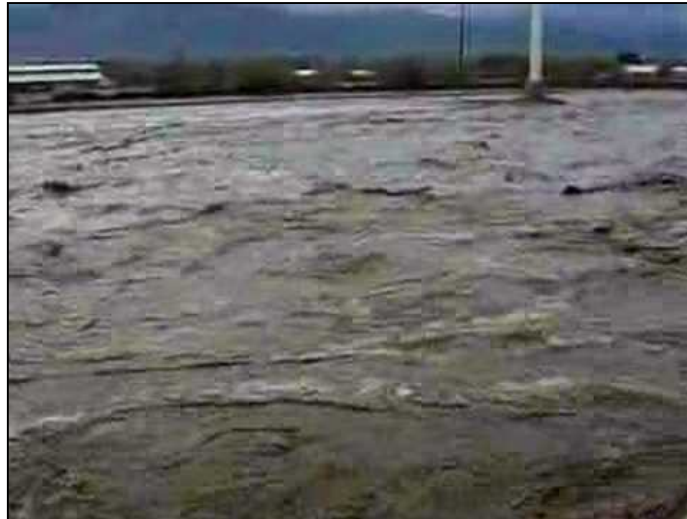
The culmination of five days of heavy rains generated by tropical storm Emilia across southeast Arizona occurred on July 31, 2006. This produced record flows on the Rillito River as well as its tributaries Tanque Verde Creek, Sabino Wash, Pantano Wash, Rincon Creek and Bear Creek in northeast Tucson. The U.S. Geological Survey's (USGS) estimate of the flood peak in the Rillito was 38,700 cfs. See Figure 10.

Figure 10. Rillito Flood from Dodge Bridge

Because most of the Rillito had Corps of Engineers designed soil-cement levee protection on both banks since 1993, the estimated damage due to the event was held to about \$4 million. The high flow overtopped the soil-cement banks near Dodge Blvd. without incident. At no location did the bank protection erode due to high velocities. It is estimated velocities were as high as 19 ft/sec.

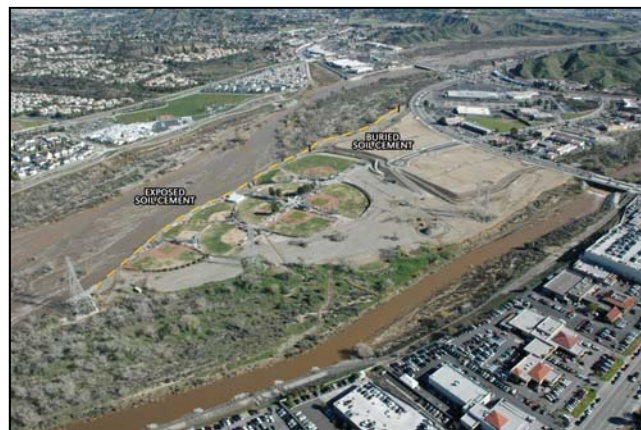
While many unstabilized areas, as well as areas protected by other bank protection methods suffered damage during 2005 flooding soil-cement has functioned faultlessly. A major test of the buried soil-cement protection occurred at the 33-acre site of the William S. Hart Baseball and Softball League fields in Santa Clarita. In the past, this area had been subject to flooding even during minor rainfall events. Because of this problem, the areas developer approved construction of 3,500 linear feet of soil-cement levee protection along the Santa Clara River and its South Fork tributary. Construction was completed in the fall of 2004, just in time for the usual rainy season. In January 2005, when the Santa Clara River rose to record levels, baseball tryouts went on as scheduled since no areas on the site were flooded. See Figure 13 for an aerial view of the Hart Baseball fields during the January 2005 storm event.

Figure 13. Aerial view of Hart Baseball Fields, Santa Clarita, CA during January 2005 storms
